Ultrasound to improve the safety of hyaluronic acid filler treatments

Leonie W. Schelke¹ MD | Tom S. Decates¹ MD | Peter J. Velthuis¹ MD, PhD

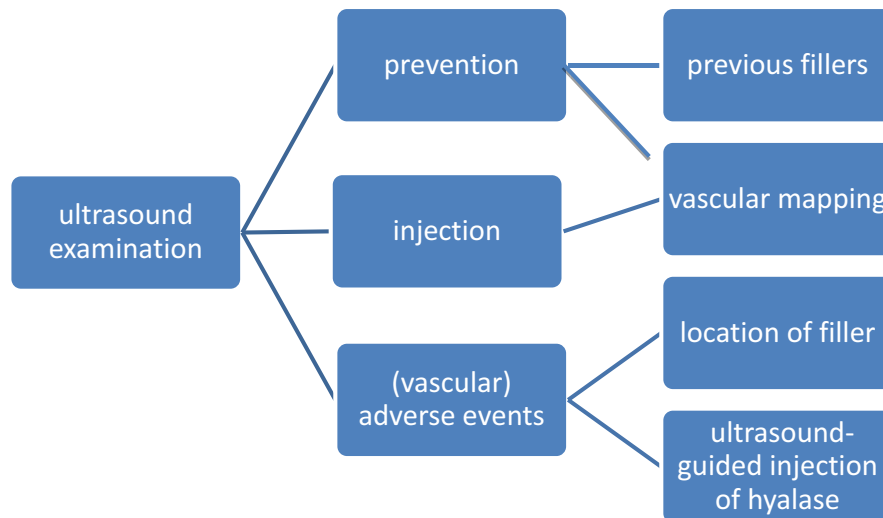
FIGURE 11 Ultrasound examination for filler treatment
